Roanoke, Town of (James Lewis Cutright House) Highway 38 (Brownsville Road) Roanoke Vicinity Lewis County West Virginia

HABS No. WV-209-N

WRITTEN HISTORICAL AND DESCRIPTIVE DATA

ROANOKE, TOWN OF (James Lewis Cutright House) HABS No. WV-209-N

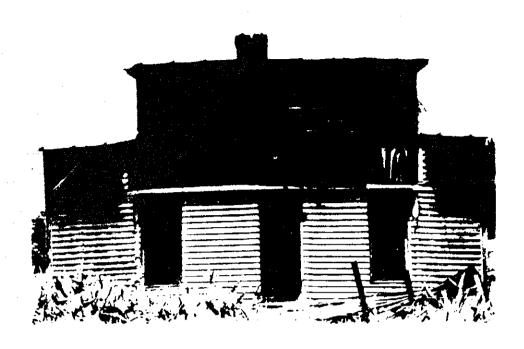
Perspective control photograph of the east elevation of the Cutright farmstead dwelling in 1981. Note the extensive vandalization that had been done to the velling before the time of the survey. As a result, it was virtually impossible to obtain precise data on many architectural elements, particularly doors and windows.

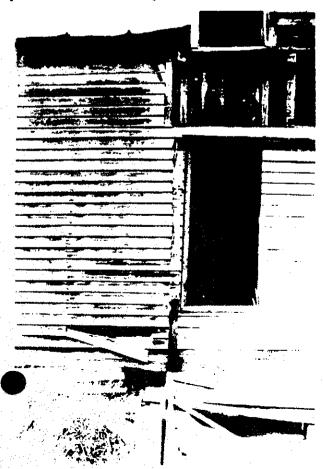
Close-up of engaged porch column on the east elevation of the Cutright farmstead dwelling in 1981.

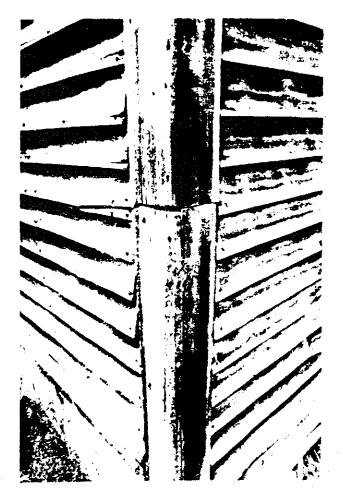
Walls: The walls are composed of 4 1/2" clapboards with corner boards and stops on the original structure; 4 1/2" clapboards with corner boards are employed on the addition; the walls are white-washed.

Close-up of corner boards and clapboards at the southeast corner of the Cutright farmstead dwelling in 1981.

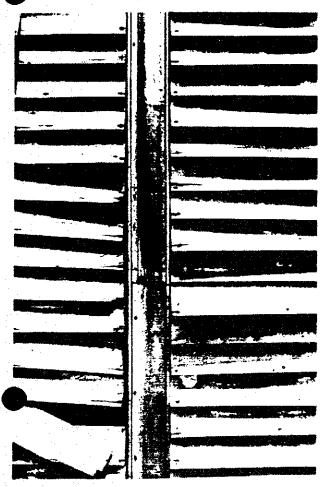
Close-up of clapboards along the south elevation of the Cutright farmstead dwelling in 1981. Note the simple-beaded corner boards at what was the southwest corner of the original structure.

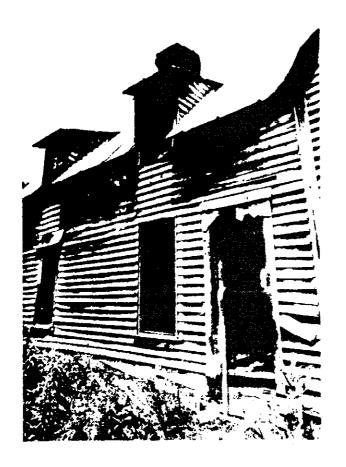
Close-up of door and window openings and second story dormers on the south elevation of the Cutright farmstead dwelling.

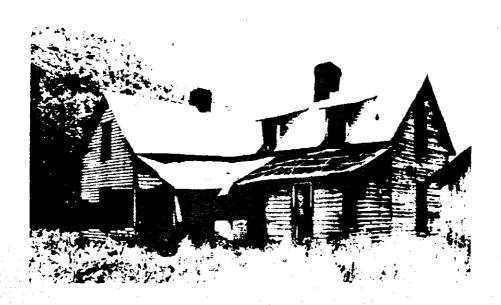
A second, ell-shaped porch measuring 147" along its north to south leg and 144" along its east to west leg still exists along the north side of the dwelling between Rooms 1 and 5.

The deck is raised 8" above grade and consists of 2"-2 1/2" unpainted tongue and groove boards.

The shed roof of the porch is covered by raised seam sheet metal roofing; the ceiling is composed of $3 \frac{1}{2}$ " tongue and grove boards painted white. The lower 2'8" of the porch is enclosed with 5" white-washed clapboards; the upper portion is screened. Access to the porch deck is from a sandstone step (48" wide x 19" tread x 5" rise) and through a screen door; sandstone flagstones lead to the step from the northern part of the property.

Perspective control photograph of the west and north elevations of the Cutright farmstead dwelling in 1981. Note the porch.

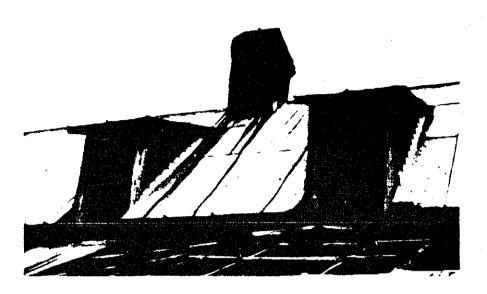
Chimneys: A single stack brick chimney is centrally located on the roof peak of the original structure, and another is at the roof peak of the addition.

Close-up of second floor dormers on the north elevation and single stack chimney at the roof peak of the Cutright farmstead dwelling in 1981.

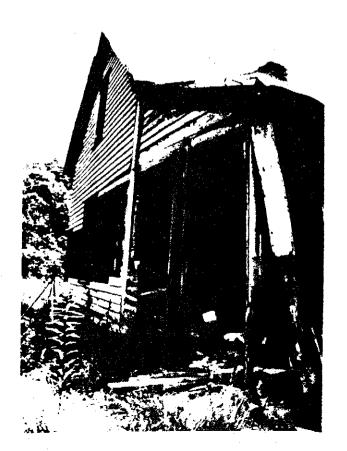
Close-up of a portion of the porch on the north side of the Cutright farmstead dwelling in 1981. Note engaged column.

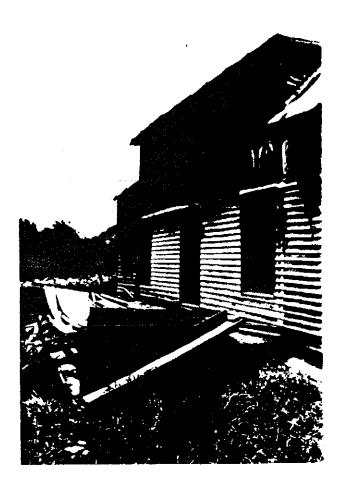
Porch: A 6'1 1/2" wide x 18'6" long x 11' high porch covered by a shed roof once stood along the east elevation; the porch deck consisted of 3 1/4" unpainted tongue and groove boards; the roof was supported by columns which are now missing and was covered with raised seam sheet metal roofing; turned pilasters are found against the dwelling at south and north ends of porch; ceiling consists of 3 1/2" tongue and groove white-washed boards; steps are now missing.

Close-up of collapsed porch roof on the east elevation of the Cutright farmstead dwelling in 1981.

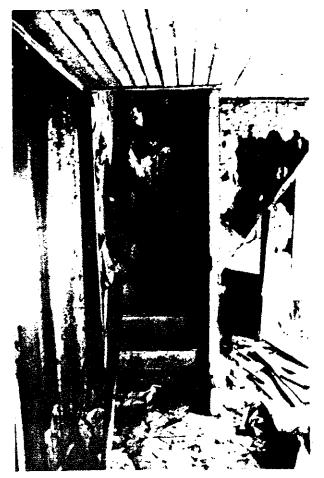
Stairway: stairway to second floor is situated in northwest corner of room: the first run consists of three steps (33 1/4" wide x 8" tread x 7" rise) with 1/4"-1/2" nosings plus a 7" riser to a 30 1/2" x 30 1/2" landing. This landing leads at a right angle to a second set of seven steps (28 1/2" wide x 6"-63/4" tread x 8" rise) with 1/4" nosings plus a riser of 5 1/2" to the second floor deck; a doorway at the base of the stairway rests on the tread of the first step. There is a closet beneath the stairway; all stair parts are white-washed.

Stairway from Room 1 to Room 6 in the Cutright farmstead dwelling in 1981

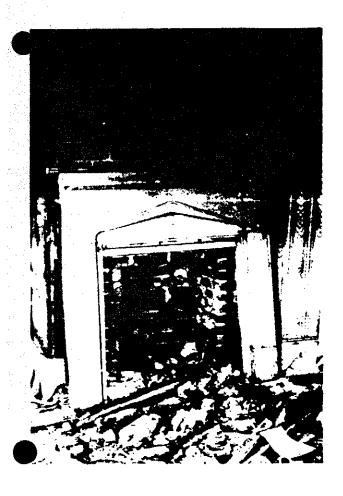
Fireplace: brick; 25 1/2" wide x 28" high x 5 1/2" deep firebox (originally 28" wide x 29" high x 11 1/2" deep); 21" x 50" sandstone hearth; wooden mantle.

Close-up of fireplace and mantle in south wall of Room I of the Cutright farmstead dwelling in 1981

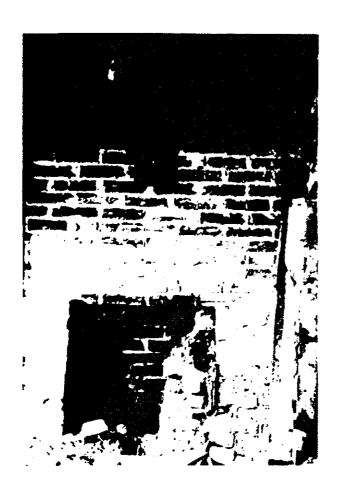
Fireplace: brick; partially destroyed firebox originally measured 27 1/2" wide x 29" high x 12" deep; 12" x 56" sandstone hearth; mantle missing.

Close-up of fireplace in west wall of Room 3 of the Cutright farmstead dwelling in 1981

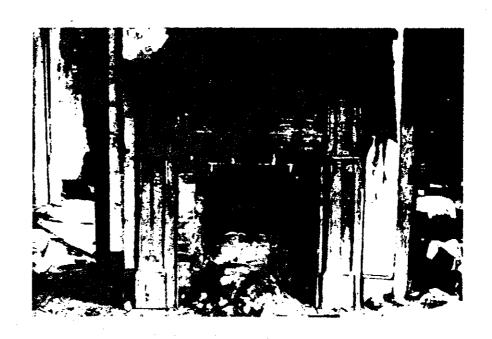
Fireplace: brick; 23" wide x 29 1/2" x 5" deep firebox; originally measured 27 1/2" wide x 29 1/2" high x 11 1/2" deep; 14" x 57" sandstone hearth; wooden mantle.

Close-up of fireplace and mantle in east wall of Room 4 of the Cutright farmstead dwelling in 1981. At left is doorway to Room 3. At right is a closet

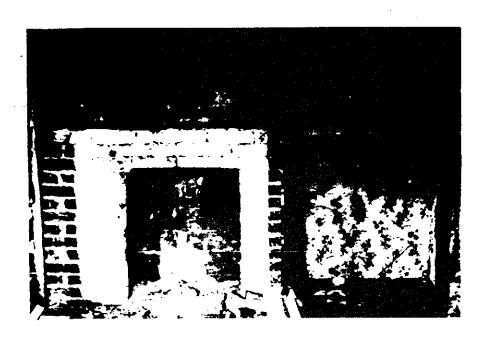
Fireplace: brick; 23 1/2" wide x 29 1/2" high x 8" deep firebox; 18" x 50" sandstone hearth; wooden mantle (destroyed).

Close-up of fireplace and closet in south wall of Room 6 of the Cutright rarmstead dwelling in 1981

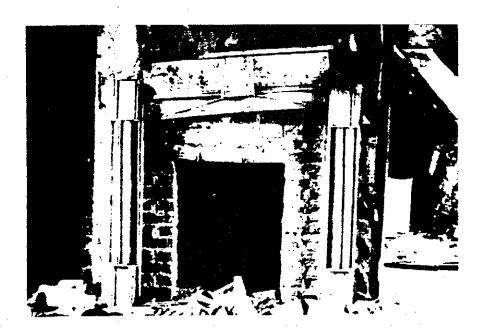
Fireplace: brick; 23" wide x 31" high x 11" deep firebox; 13" x 54 1/2" sandstone bearth; wooden mantle.

Close-up of fireplace and mantle in west wall of Room 8 of the Cutright farmstead dwelling in 1981. Doorway to Room 9 is visible at right

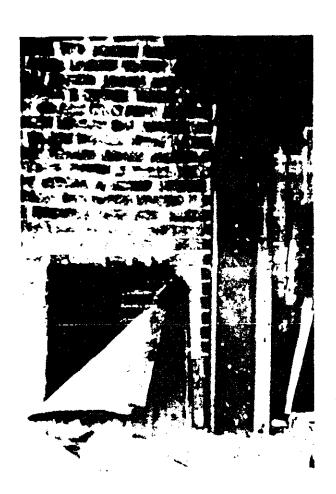
Fireplace: brick; 23" wide x 31 1/2" high x 12 1/2" deep firebox; 10 1/2" x 54" sandstone hearth; mantle destroyed.

Close-up of fireplace in east wall of Room 9 of the Cutright farmstead dwelling in 1981

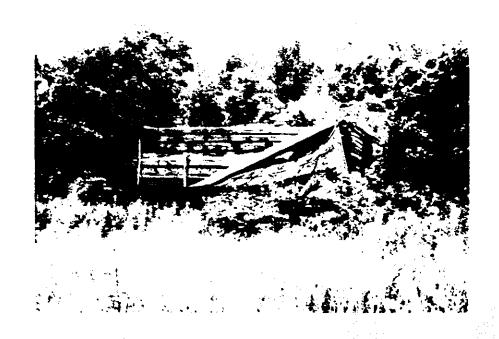
Description: The barn is a two story half-dovetail notched log structure with shed additions attached to the west and east elevations; shed-roofed sections are covered with raised seam sheet metal roofing; roofing material of log crib is unknown; there is a manger along the east wall of the log crib; animal stalls are found opposite the manger in the shed addition; sandstone foundation piers occur along the south wall.

Collapsed log construction barn southwest of the Cutright farmstead dwelling in 1981. Photograph looks west.

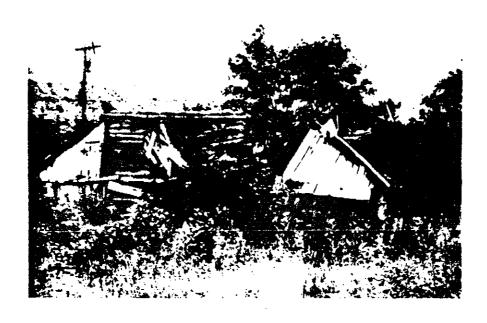
Southwest corner of the collapsed log construction barn southwest of the cutright farmstead dwelling in 1981.

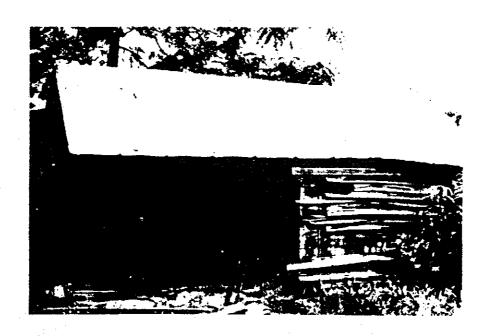
Description: The cellar house is built into a bank; it has a sandstone foundation and root cellar storage area, the walls of which are partially destroyed; a storage shed is built over the sandstone foundation and overhangs it 6' on the east side. The frame structure has vertical plain board (9"-10" wide) walls covered by 4" white-washed clapboards and a gable roof covered with raised seam sheet metal roofing; windows in the cellar house are centrally located in the north (28" x 51") and east walls (29" x 55"); much of the west and south walls of the cellar house have been removed.

South elevation of partially-collapsed cellar house northeast of the Cutright farmstead dwelling in 1981.
